LAWRENCE
LIVERMORE
NATIONAL
LABORATORY

LLNL-TR-648143

A Visual Description of the Concrete Exterior of the Cactus Crater Containment Structure

October 2013

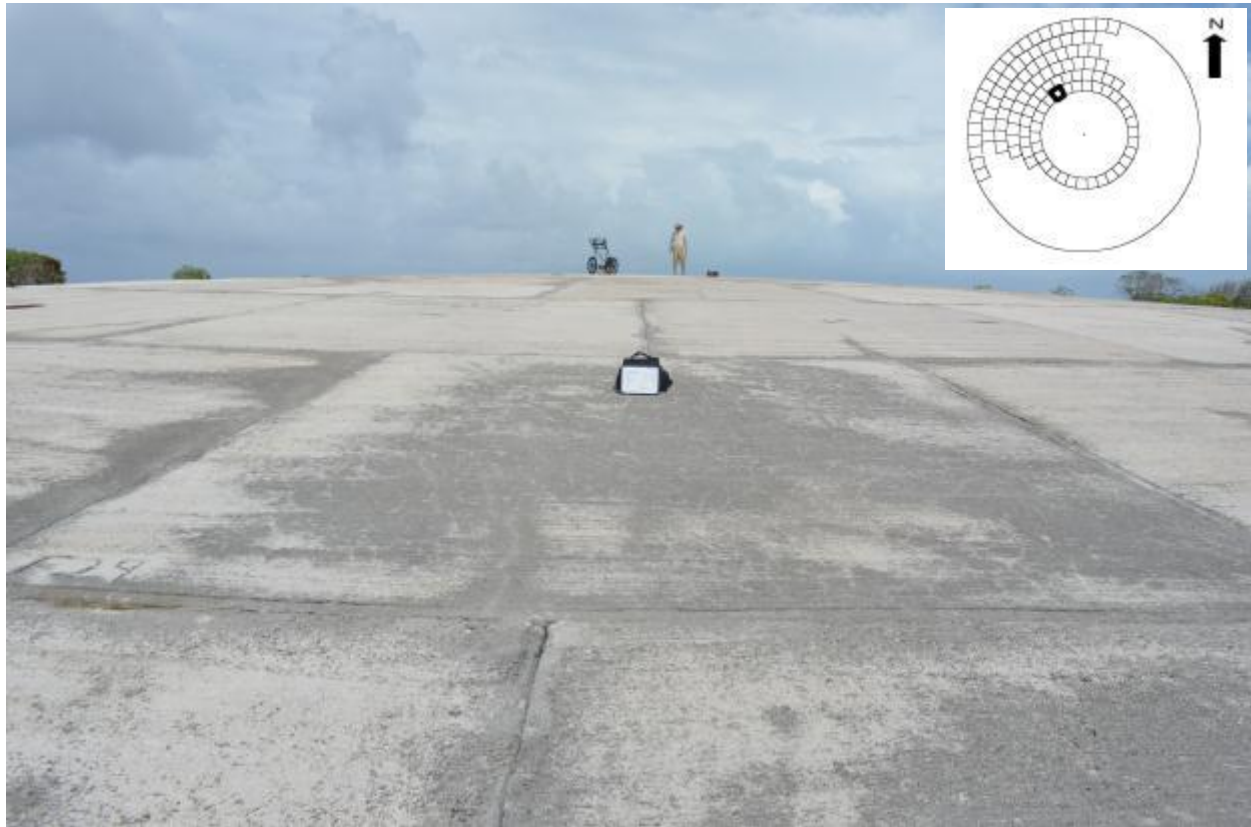
CAP SECTION LOCATION: Panel F29

The panel has a rough weathered appearance. No significant cracks or spall elements identified. Some spalling/chipping of concrete in upper right-hand corner and along the seams of the panel.

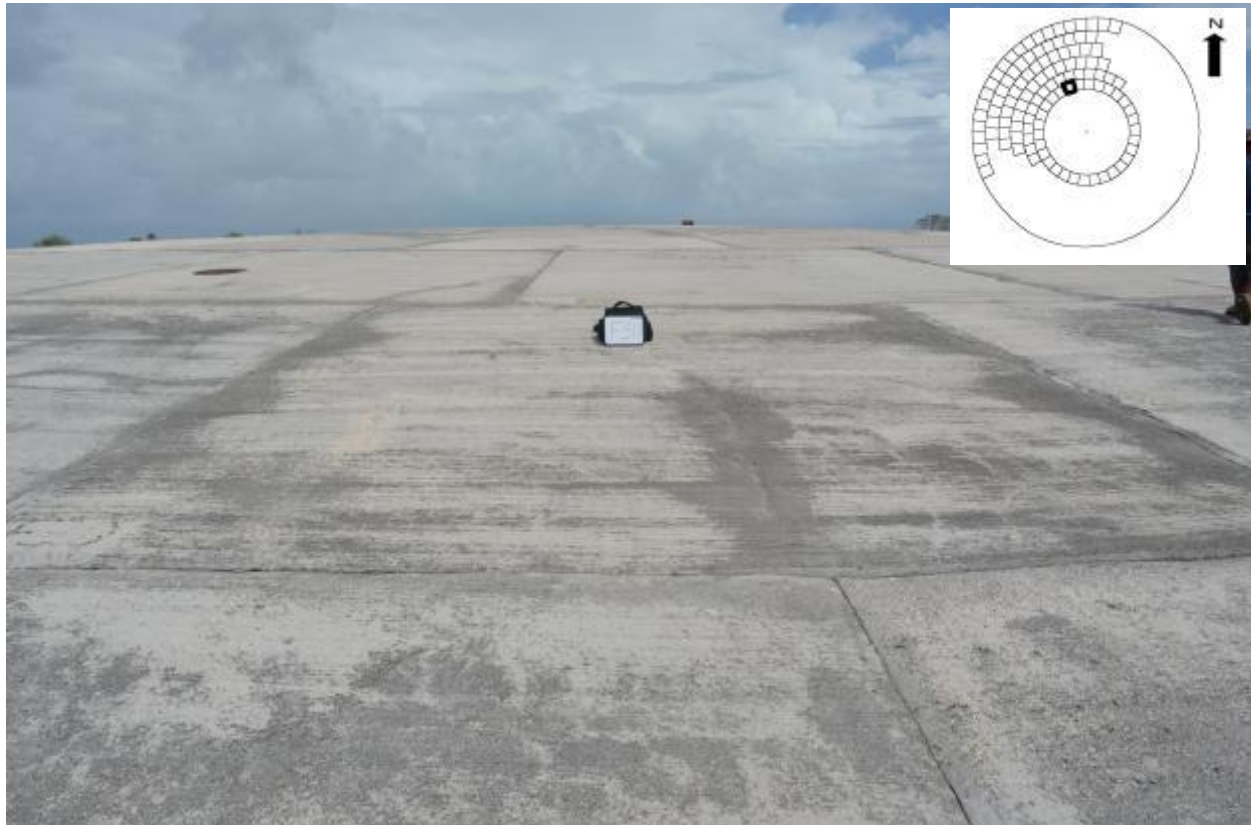
CAP SECTION LOCATION: Panel F30

No significant cracks or spall elements identified. Some spalling/chipping of concrete in upper left-hand corner and along the seams of the panel.

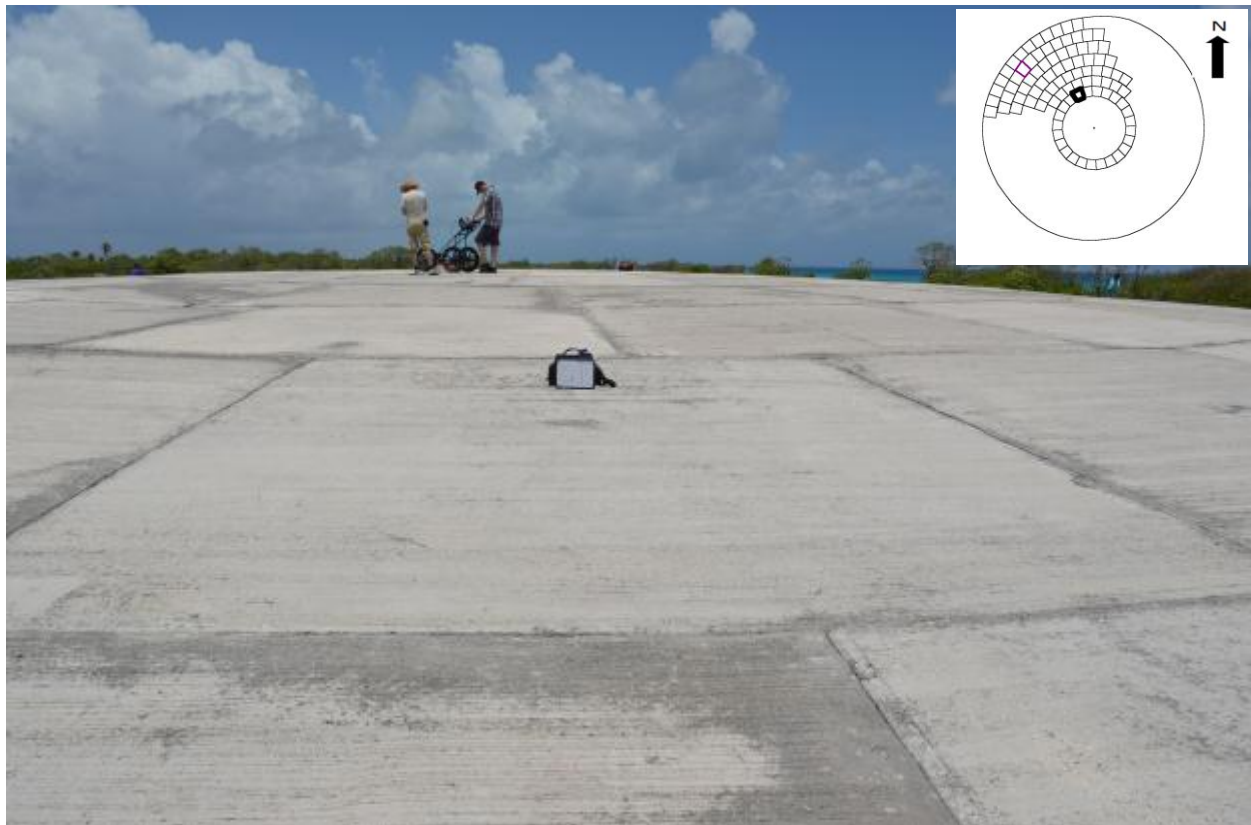
CAP SECTION LOCATION: Panel G1

No significant or obvious interior cracks or spall elements identified. Minor spalling/cracking of concrete in the upper left-hand corner of the panel.

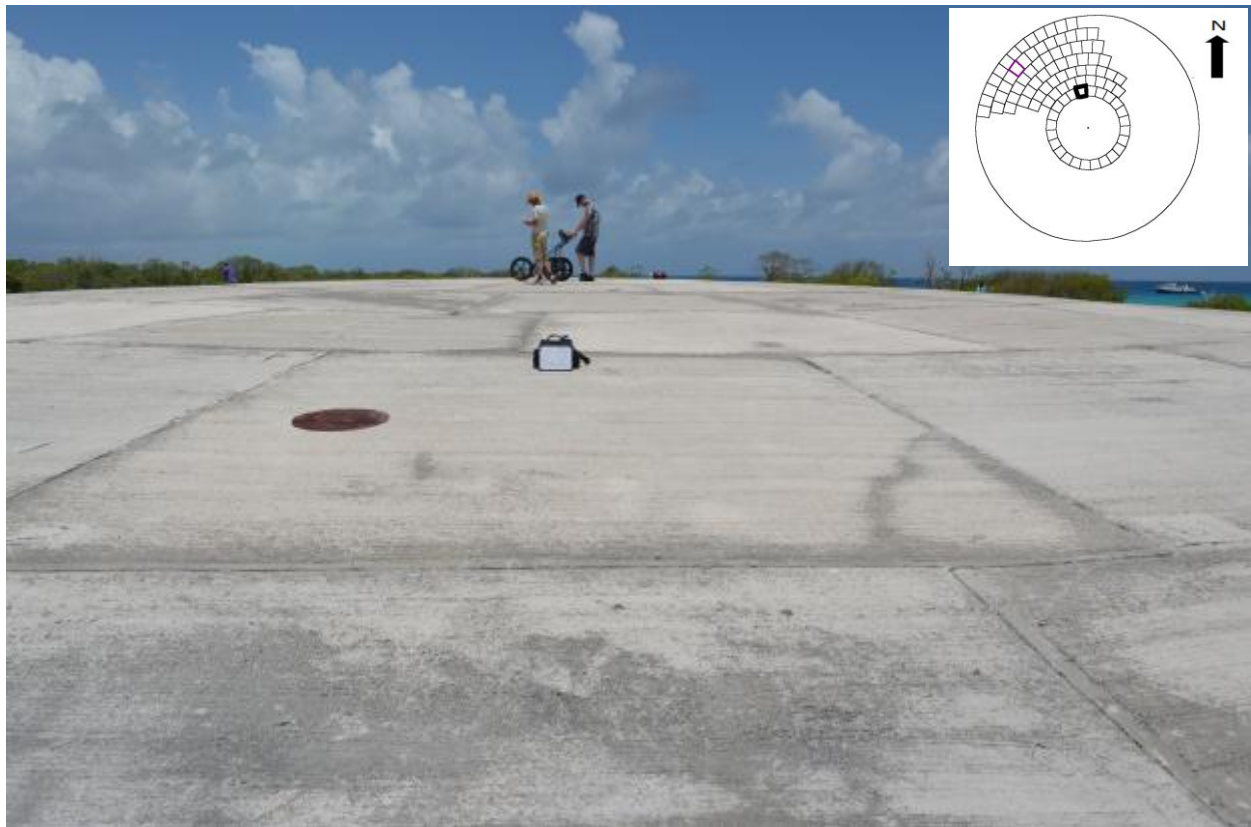
CAP SECTION LOCATION: Panel G2

Surface crack observed traversing across the bottom right-hand corner of the panel. The crack intersects the bottom and left-hand seams of the panel at a distance of about 1.2 meters and 2 meters from the right-hand corner, respectively. The panel contains a vertical elevation benchmark.

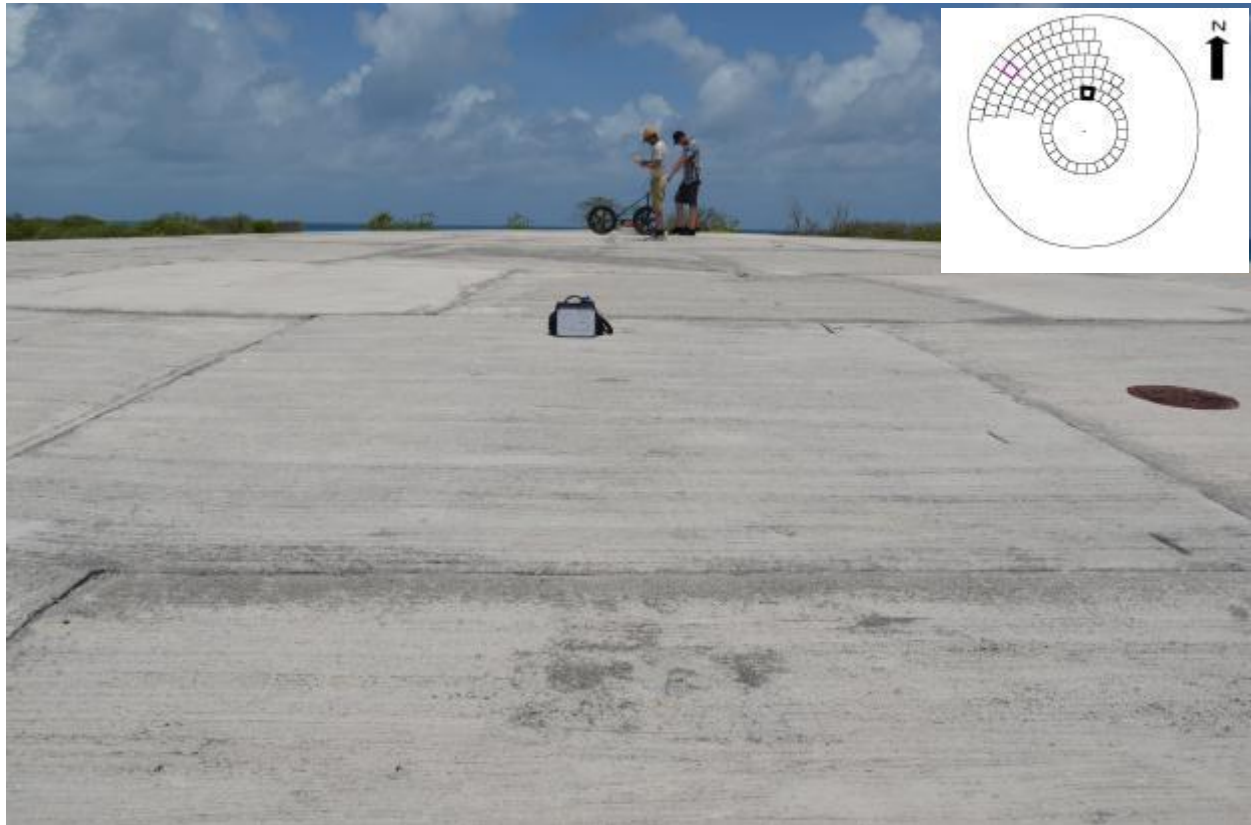
CAP SECTION LOCATION: Panel G3

No significant or obvious interior cracks or spall elements identified.

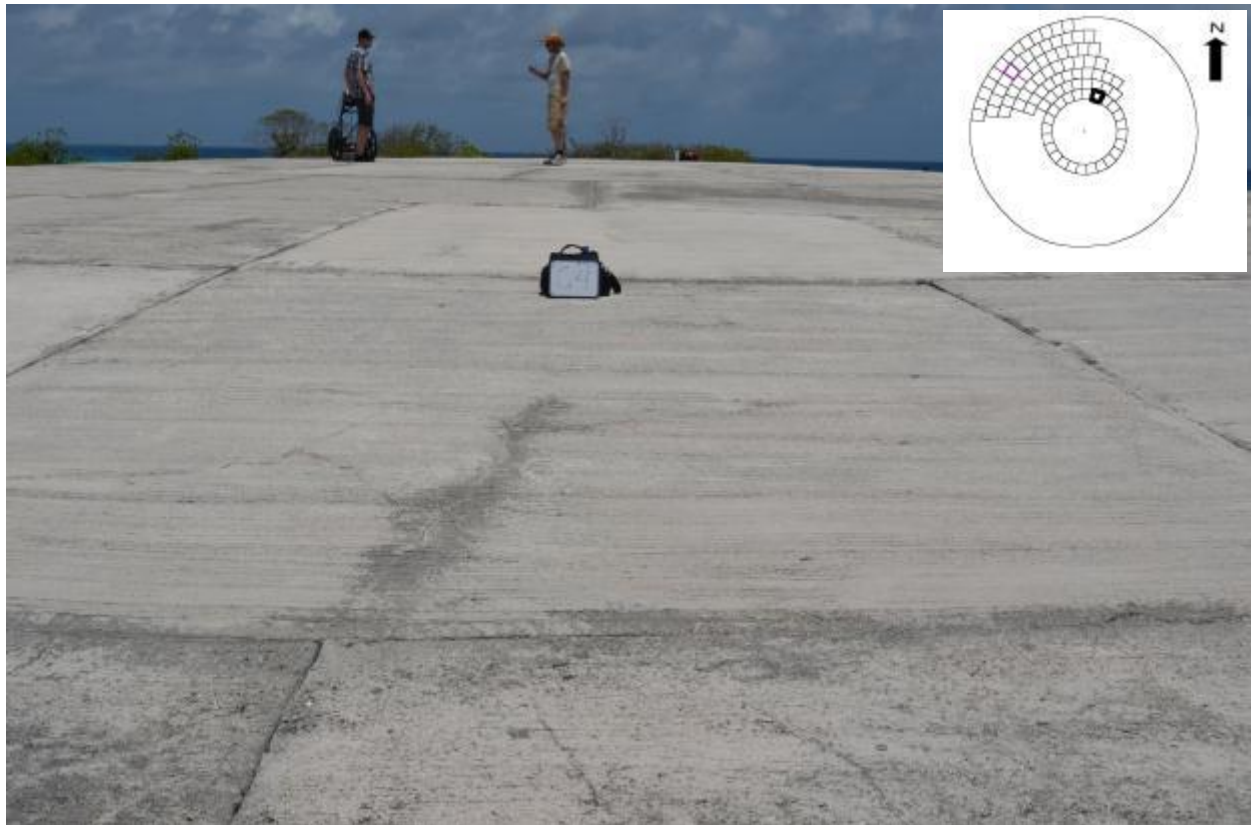
CAP SECTION LOCATION: Panel G4

Multiple surface cracks crisscrossing the bottom portion of the panel. Minor spalling/chipping of concrete observed in the upper left-hand corner of the panel.

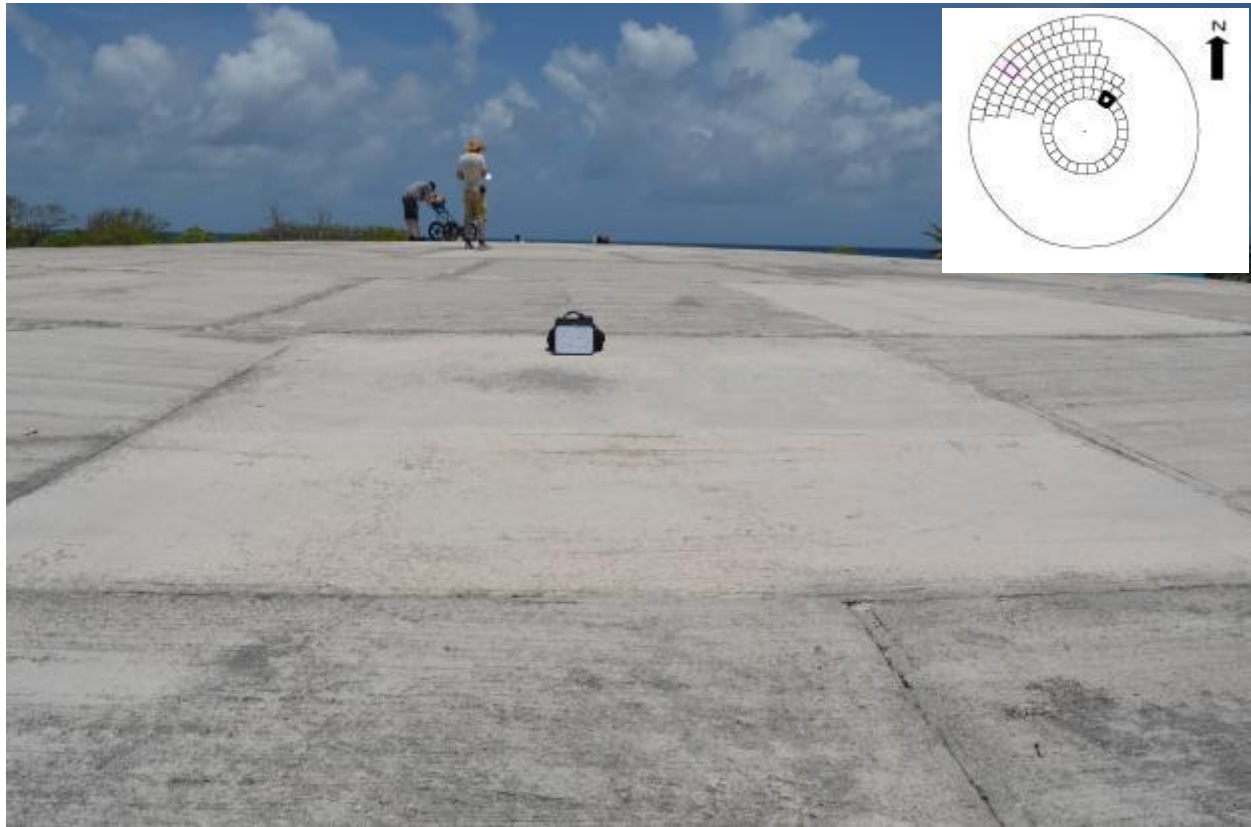
CAP SECTION LOCATION: Panel G5

Minor surface crack observed traversing up from a central position along the bottom seam of the panel for a distance of about 2 meters.

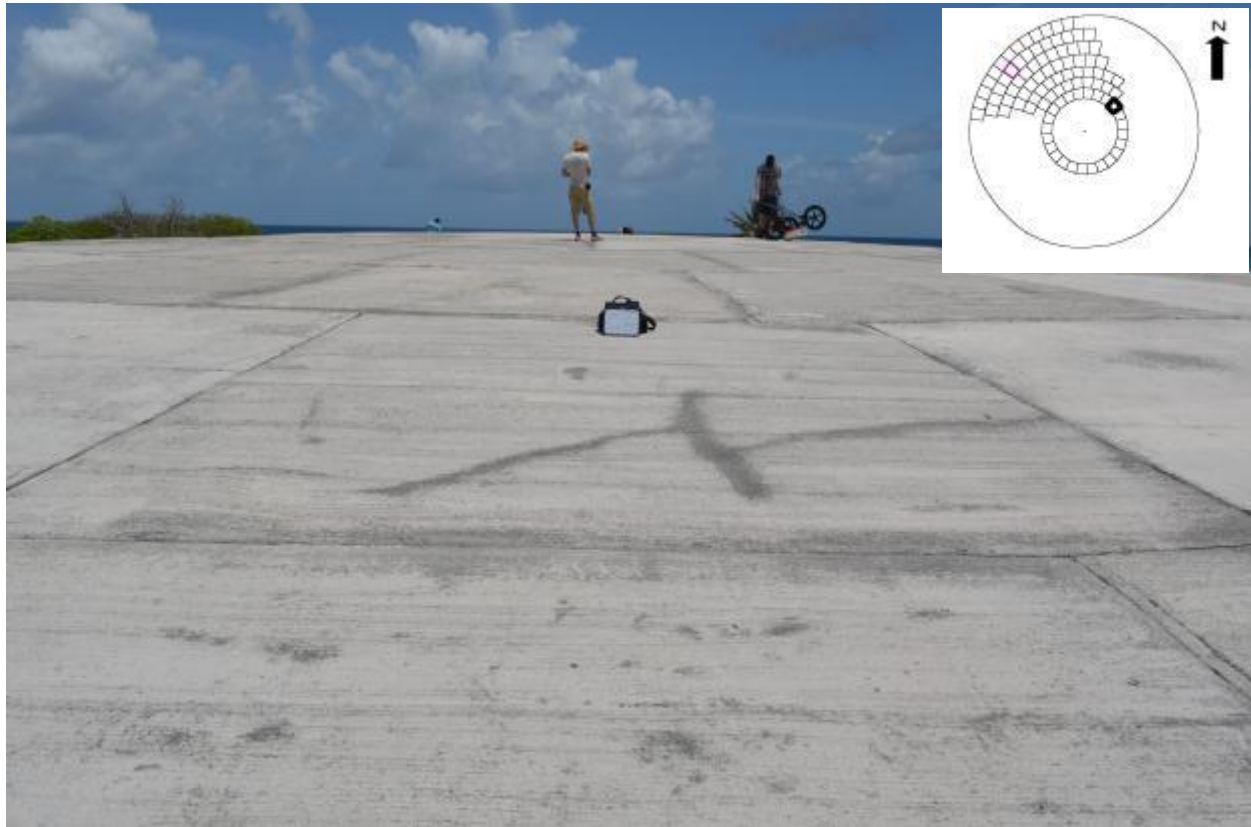
CAP SECTION LOCATION: Panel G6

There is a surface crack on the bottom, right-hand side of the panel along with a small weathered out void (or hole) in the concrete. The void is about 5 centimeters long and 1.5 centimeters wide.

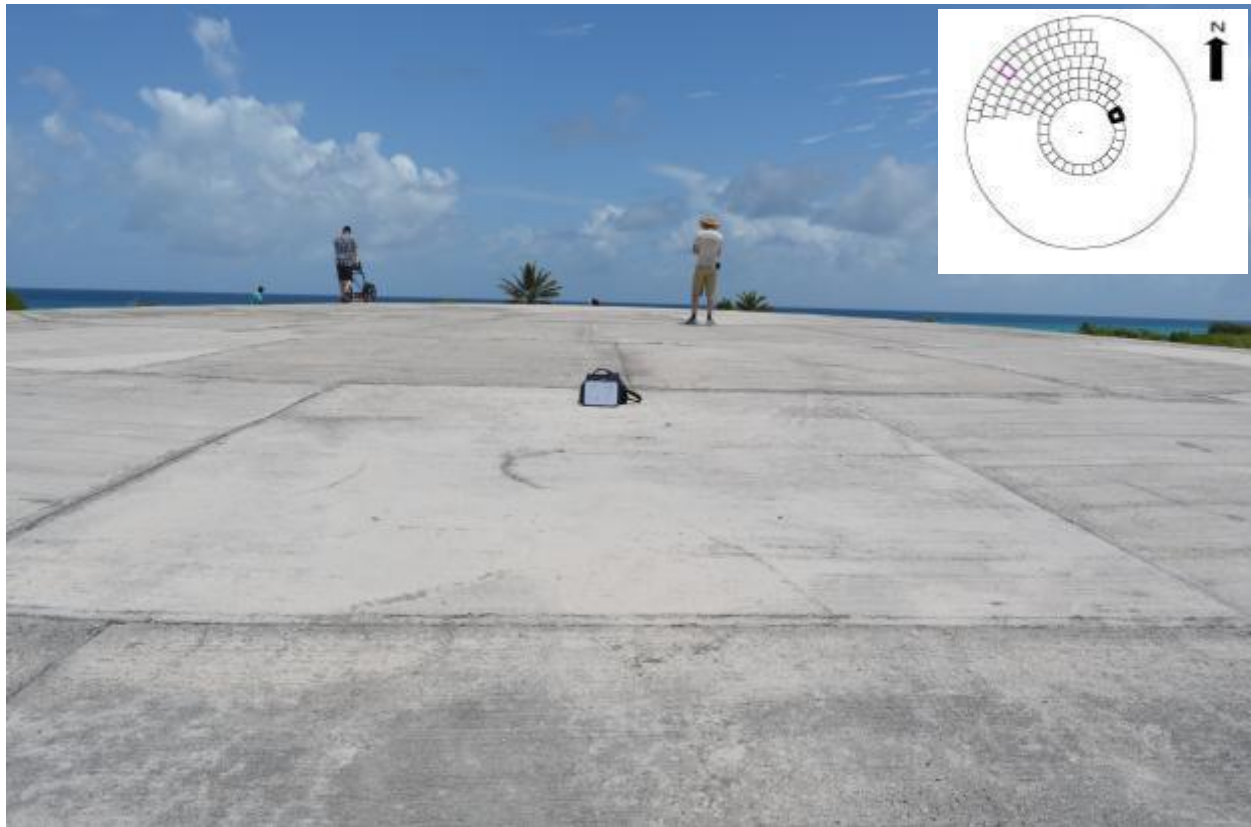
CAP SECTION LOCATION: Panel G7

A surface crack identified traversing up through the center of the panel with branches out to the left and right-hand sides of the panel.

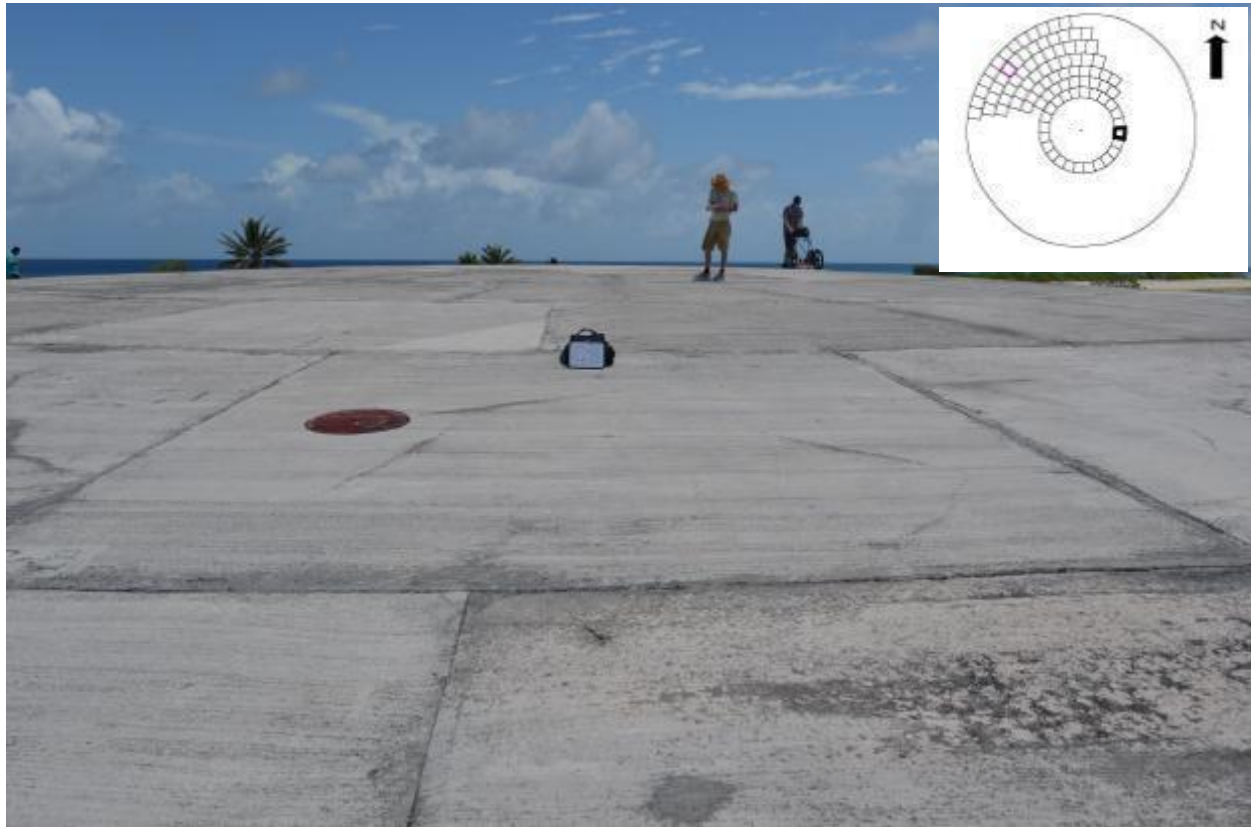
CAP SECTION LOCATION: Panel G8

A fork shaped surface crack identified extending out from the right-hand seam commencing about 1.2 meters from the bottom of the panel. The panel contains a vertical elevation benchmark.

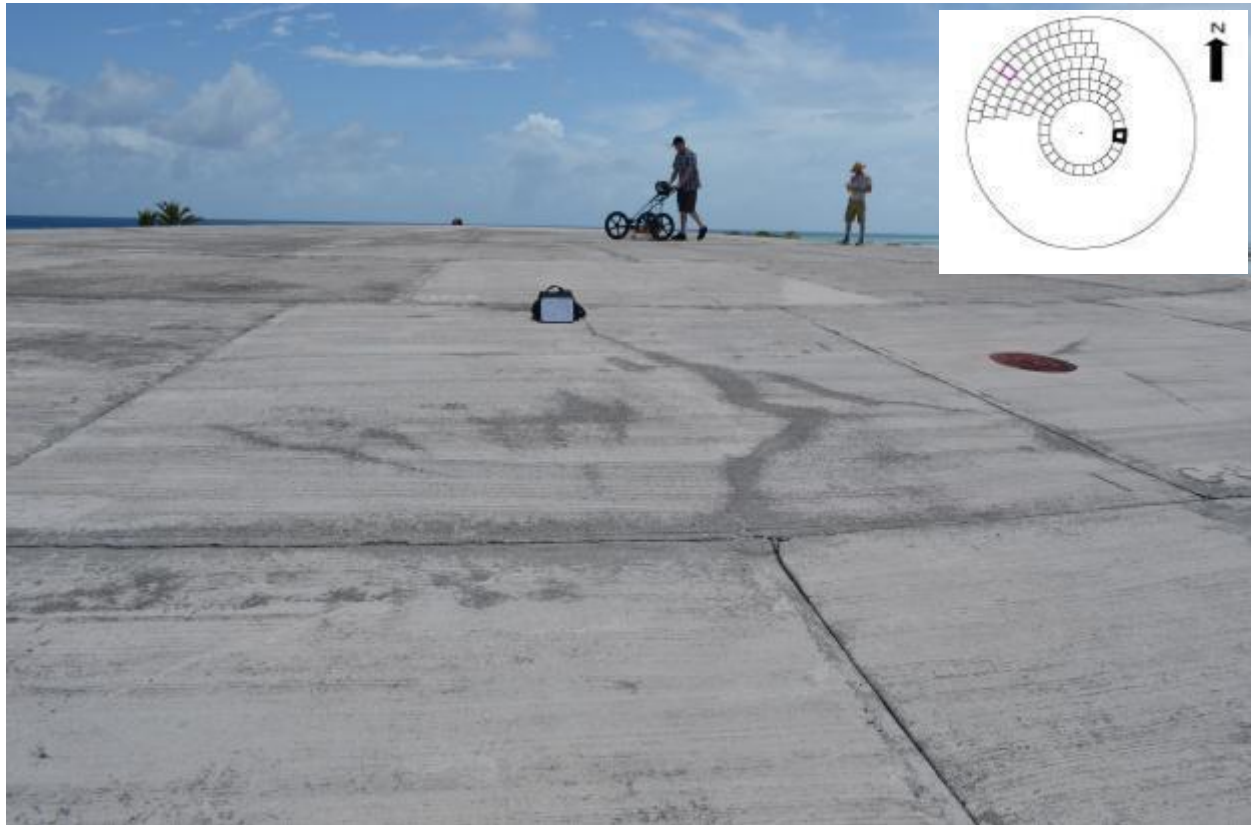
CAP SECTION LOCATION: Panel G9

No significant or obvious interior cracks or spall elements identified. Minor spalling/cracking of concrete in the upper right-hand corner of the panel.

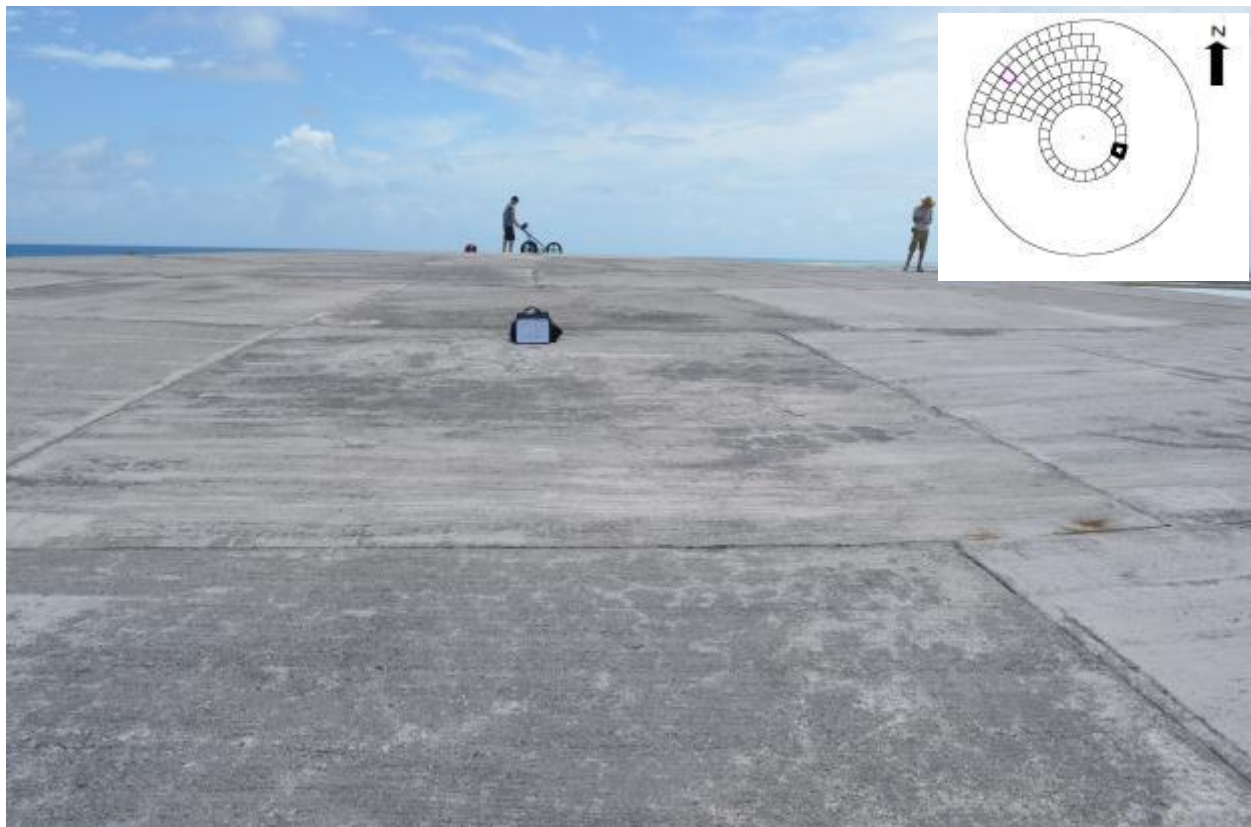
CAP SECTION LOCATION: Panel G10

No significant or obvious interior cracks or spall elements identified. Minor spalling/cracking of concrete in the upper left-hand corner of the panel.

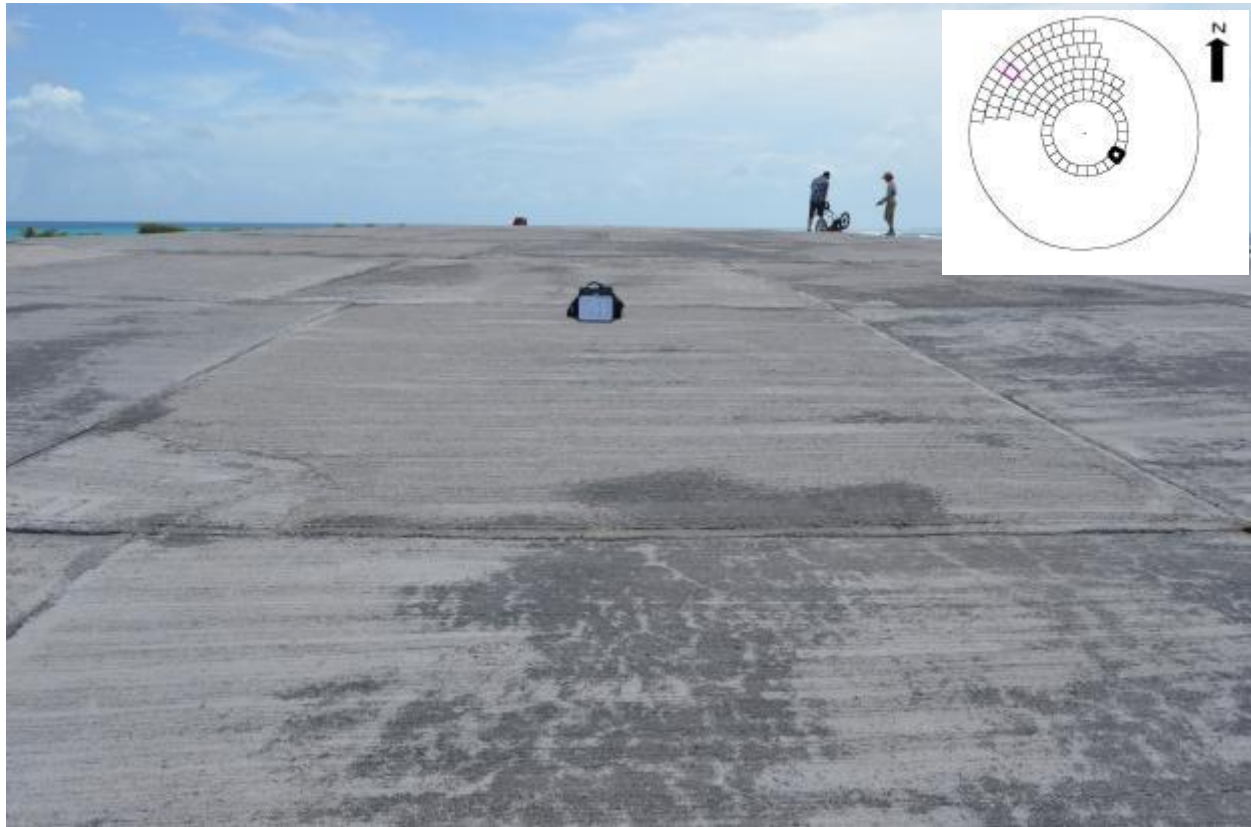
CAP SECTION LOCATION: Panel G11

The panel contains no significant or obvious interior cracks or spall elements. Rooting vegetation removed from along the panel seams. Minor spalling/cracking of concrete in the lower right-hand corner of the panel.

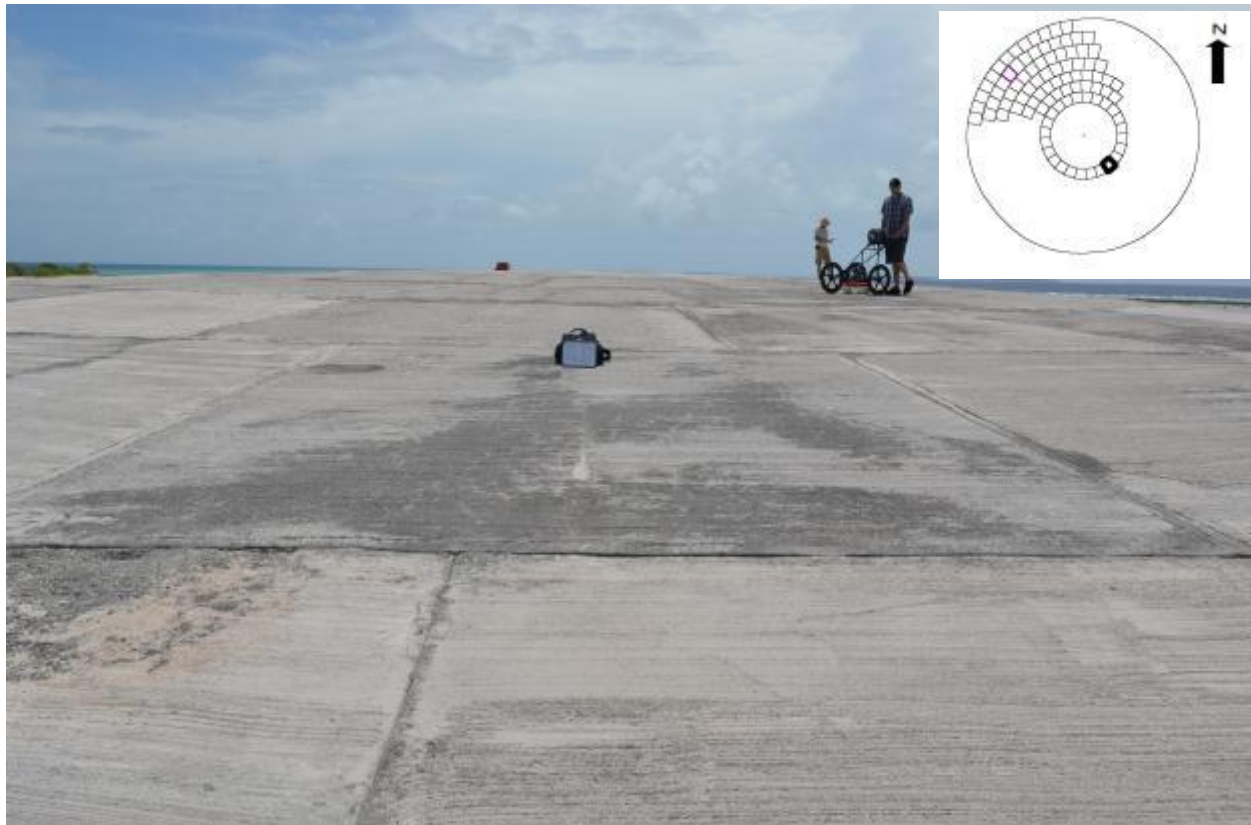
CAP SECTION LOCATION: Panel G19

Surface crack observed extending up through the middle of the panel intersecting the upper seam at corner H11/H12 on the ring row above. Panel contains a capped concrete bore-hole (CD-6) from the 1980 NAS investigation.

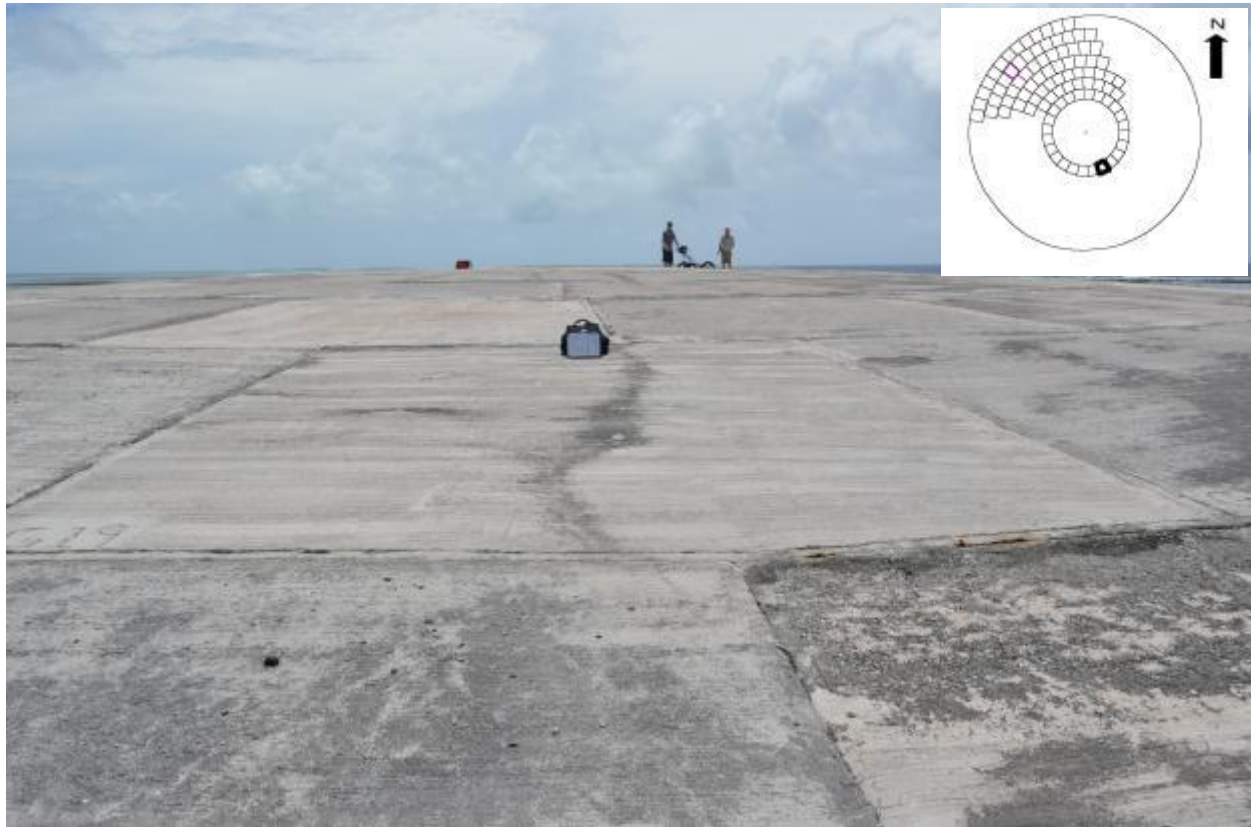
CAP SECTION LOCATION: Panel G20

The panel contains no significant or obvious interior cracks or spall elements. Panel contains a vertical elevation benchmark.

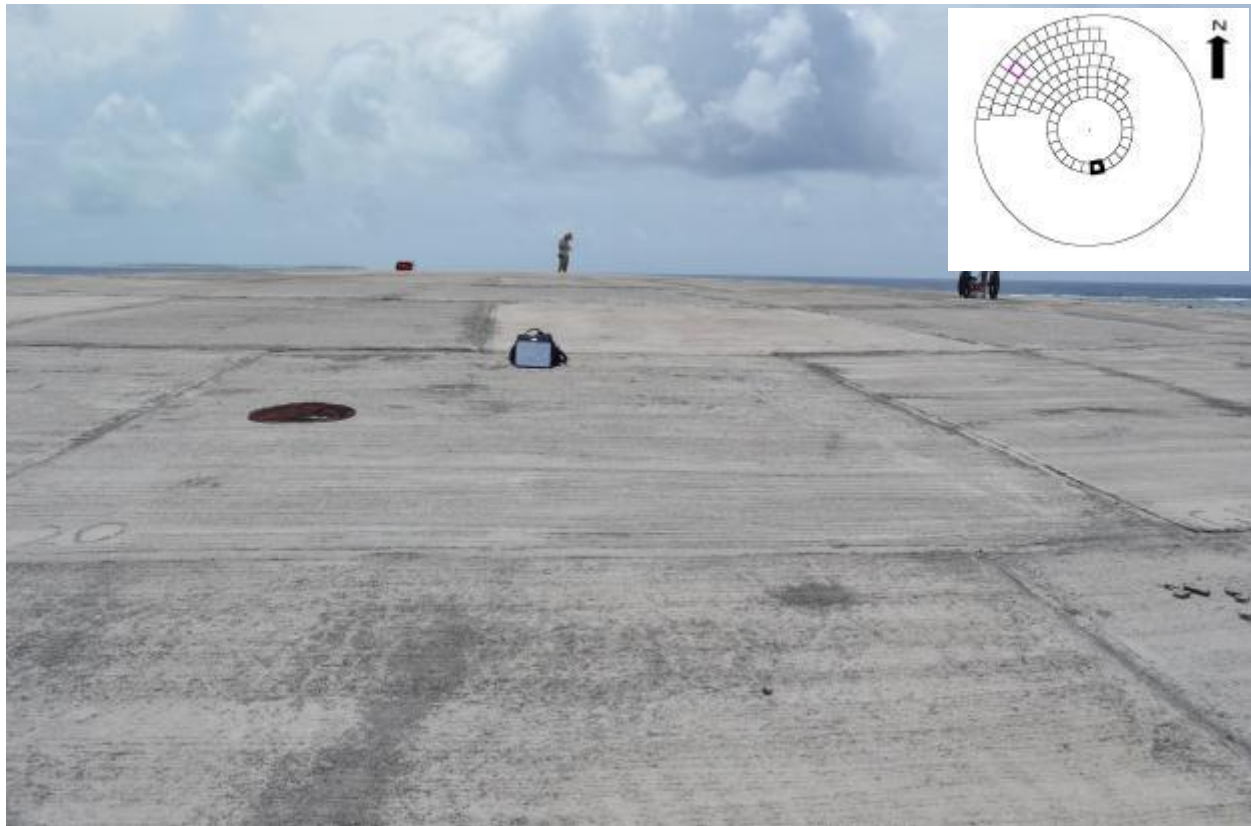
CAP SECTION LOCATION: Panel G21

The panel contains no significant or obvious interior cracks or spall elements. Some minor spalling/chipping of concrete along the upper left-hand seam. A small void observed in the concrete close to the right-side seam (refer photo). There some indication that the cracks along the panel joints are becoming more prominent compared with other panels contained in this ring row.

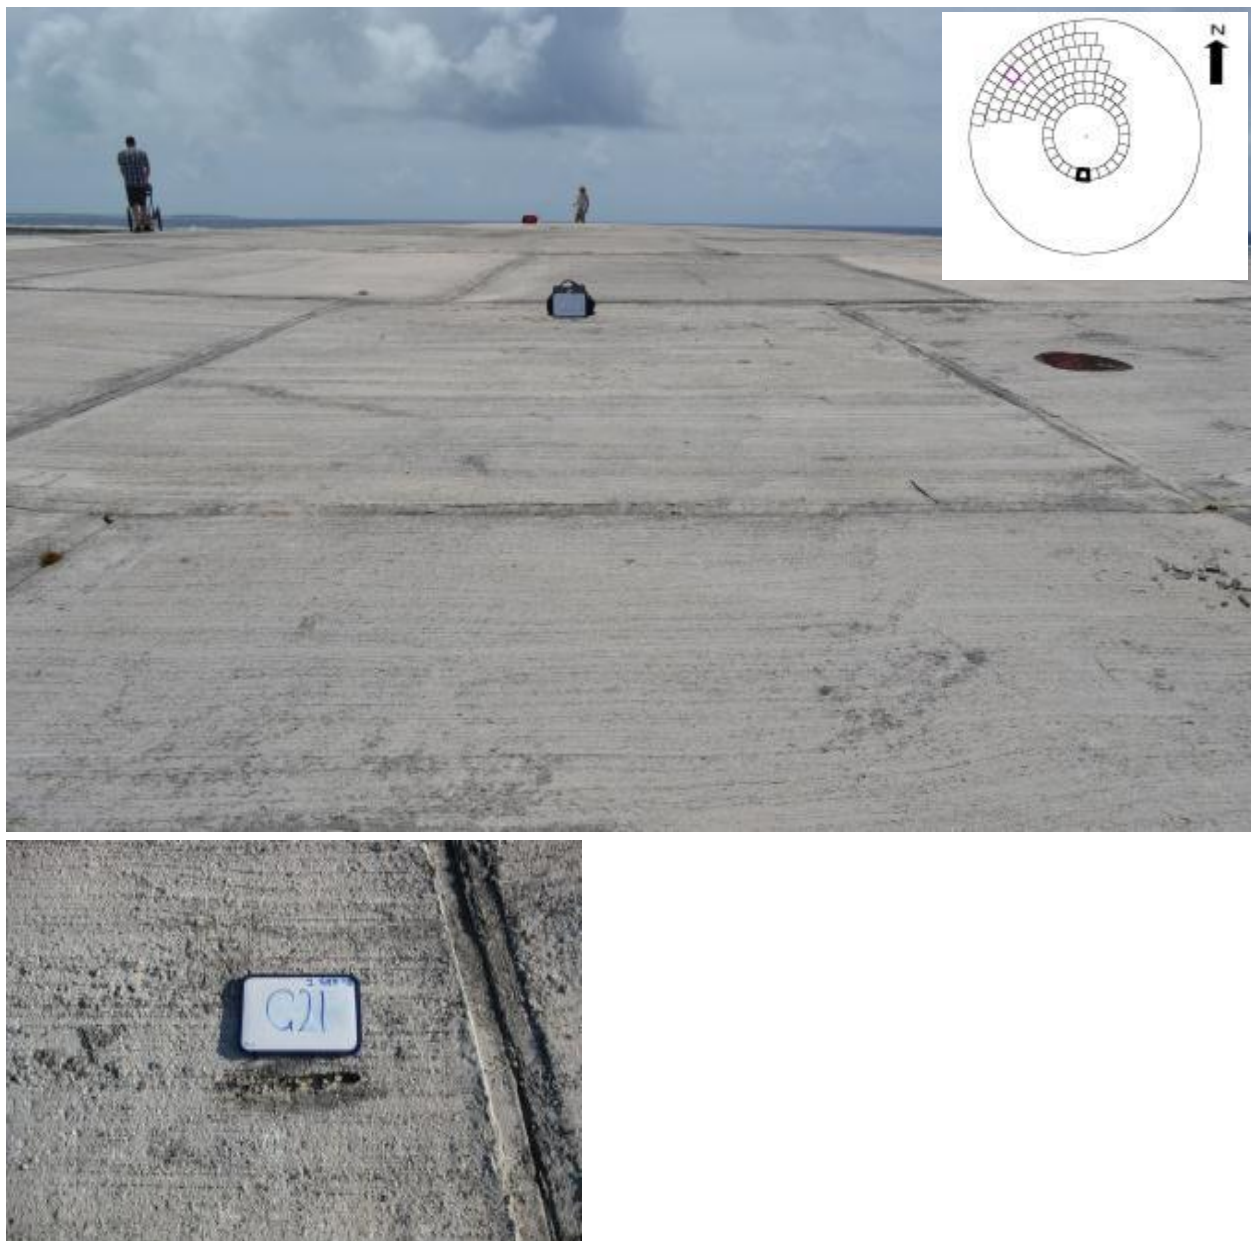
CAP SECTION LOCATION: Panel G22

The panel contains no significant or obvious interior cracks or spall elements. The cracks opening up along the panel joints appear to be a little prominent compared with other panels located in this ring row.

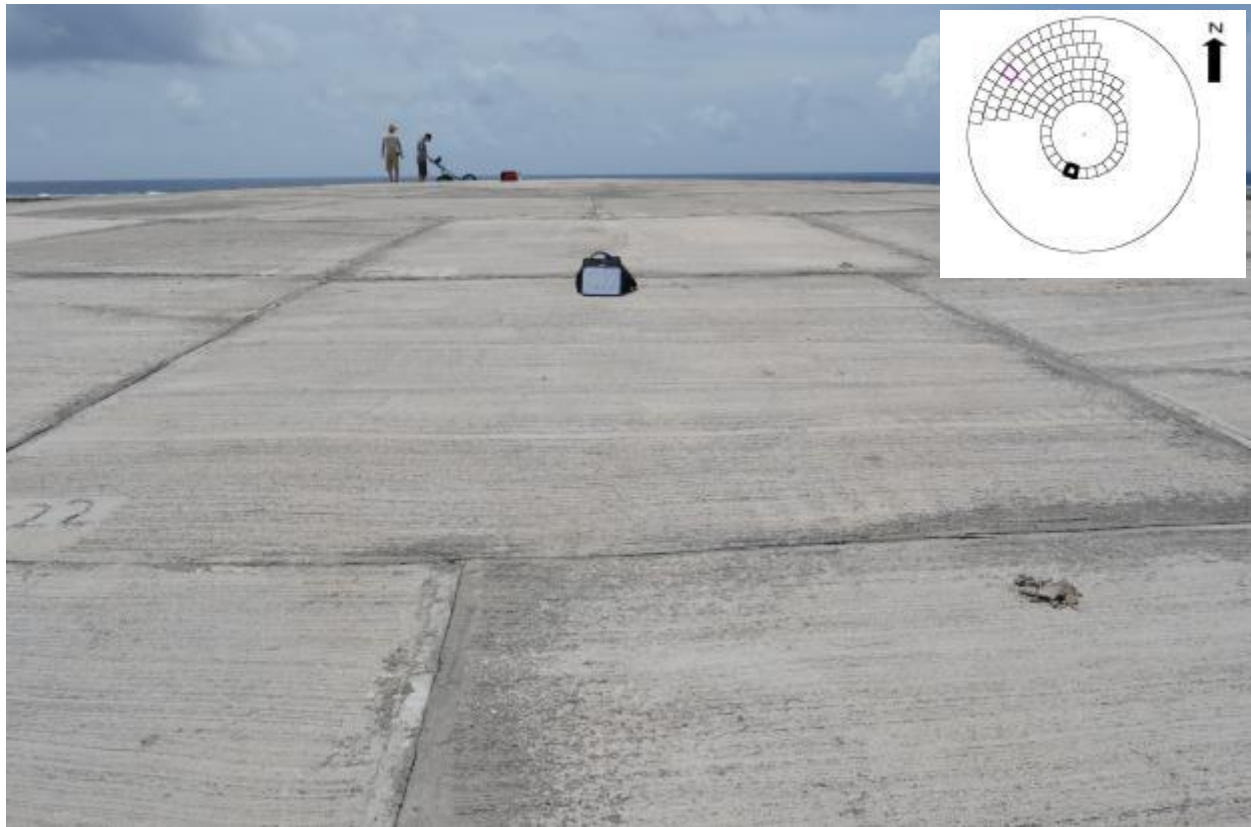
CAP SECTION LOCATION: Panel G23

The panel contains no significant or obvious interior cracks or spall elements. Some spalling/cracking of concrete along the bottom left-hand corner of the panel.

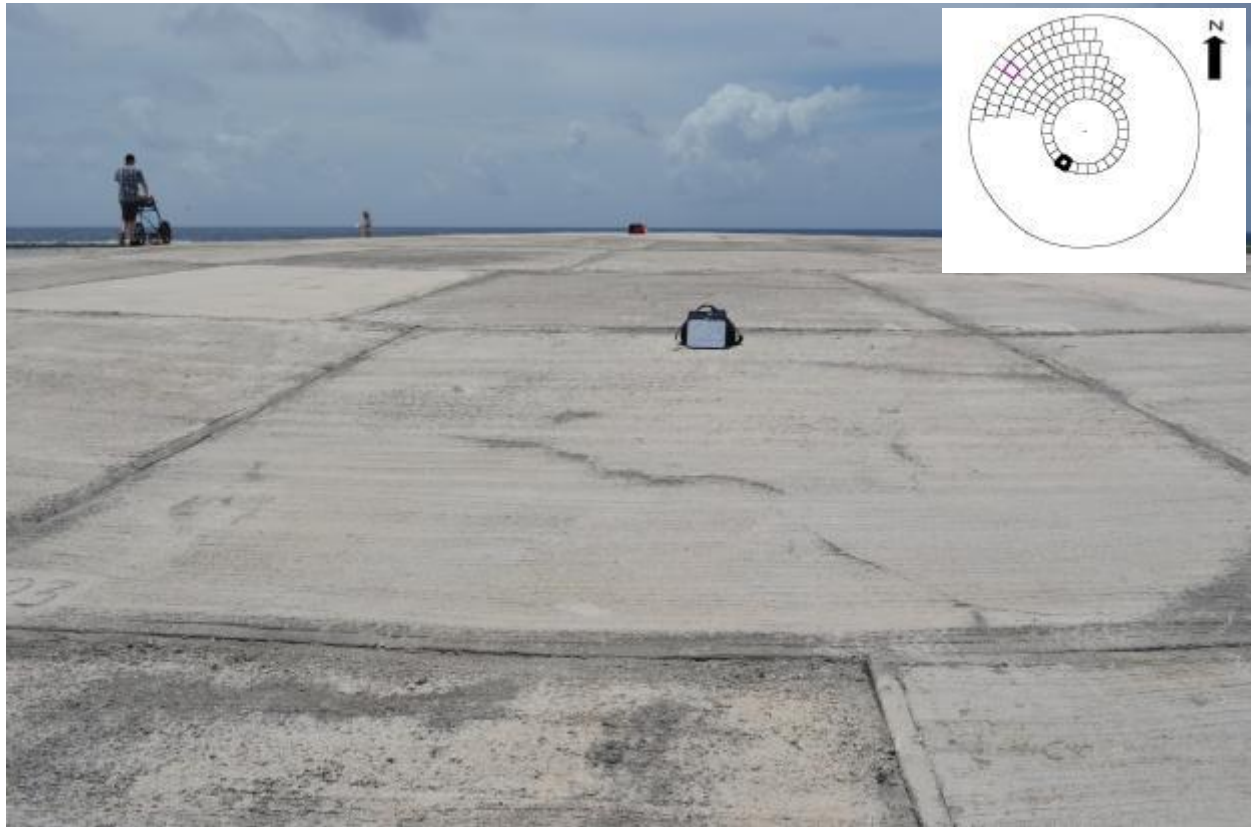
CAP SECTION LOCATION: Panel G24

Some spalling/cracking of concrete observed in the upper left-hand corner of the panel. Minor crack observed about 1.2 meters from the bottom right-hand corner and traversing up the face of the panel for a distance of about 5 meters.

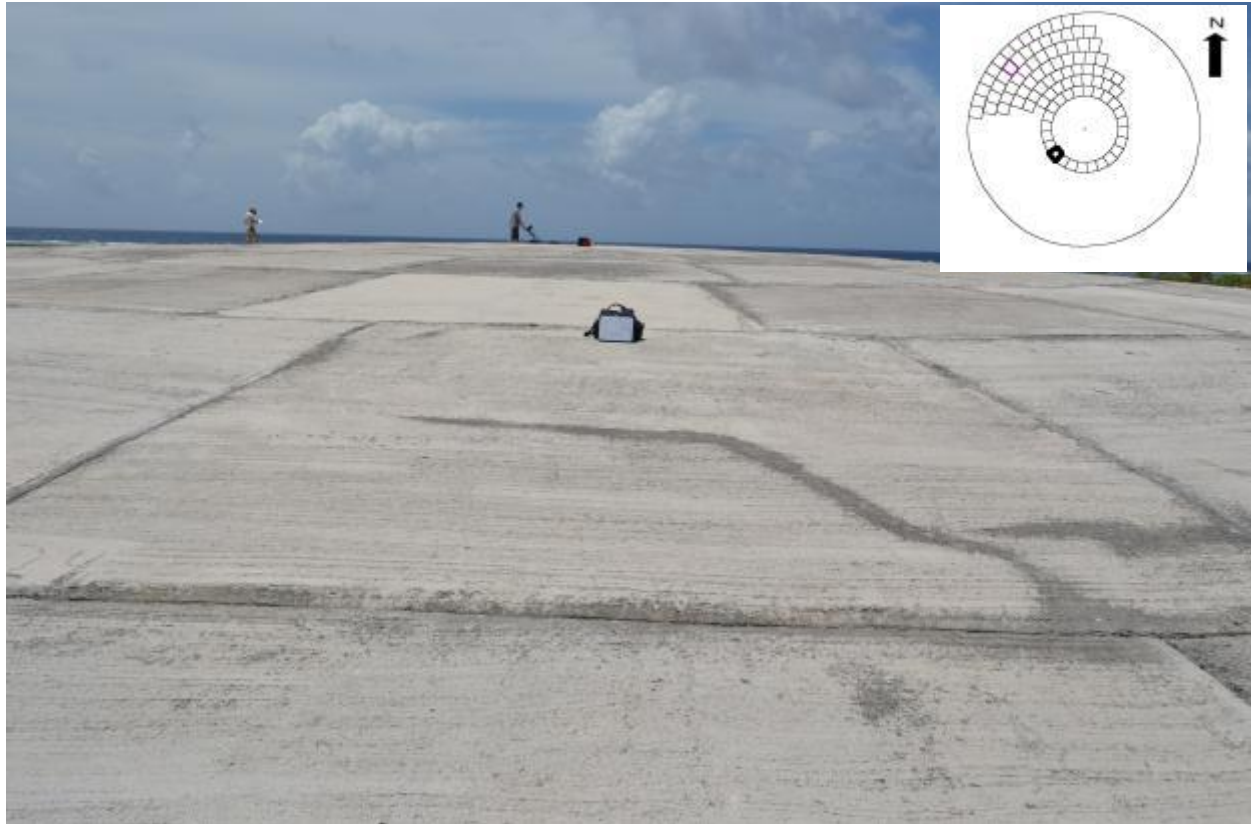
CAP SECTION LOCATION: Panel G25

The panel contains no significant or obvious interior cracks or spall elements.
